Safe Areas for the Placement of Standard Shoulder Arthroscopy Portals. An Anatomical Study

ESPINOSA-URIBE, A. G.; MORALES-AVALOS, R.; GUTIÉRREZ-DE LA O, J.; GARCÍA-DE LEÓN, O. R.; TORRES-GARCÍA, J. K.; GUZMÁN-AVILÁN, K.; VÉLCHEZ-CAVAZOS, F.; DE LA GARZA-CASTRO, O.; GUZMÁN-LÓPEZ, S. & ELIZONDO-OMAHÑA, R. E. Safe areas for the placement of standard shoulder arthroscopy portals. An anatomical study. *Int. J. Morphol.*, 33(4):1386-1392, 2015.

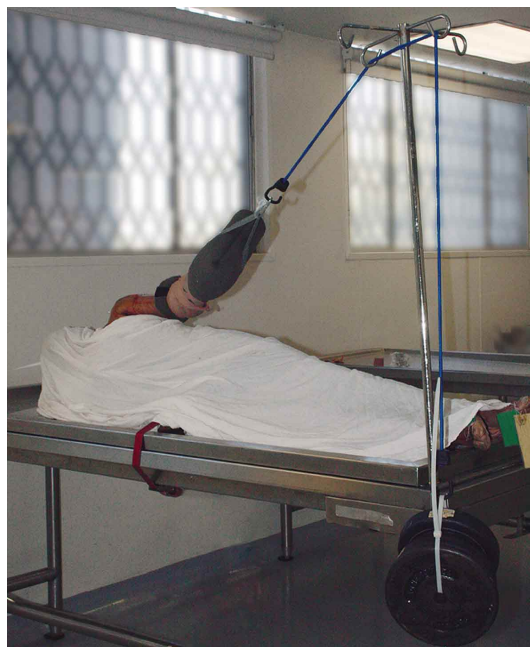
Fig. 1. Positioning the body for the placement of arthroscopic portals. Anterior view.

The standard surgical protocol for the body position, upper limb traction, as well as portal location and positioning was followed. The body was placed in the lateral decubitus position, the upper extremity was placed in 15° abduction, and traction was applied downward with a weight of 9.71 kg (20 lbs) (Fig. 1). Subsequently, bony landmarks of the acromion, clavicle and acromioclavicular joint were identified and marked using a surgical marker. Finally, the SPP, and SAP were placed following the classic description in the literature (McGinty *et al.*, 2005; Meyer *et al.*; Gumina *et al.*). Although there are other shoulder portals (not evaluated in this study), SPP and SAP are the most commonly used.

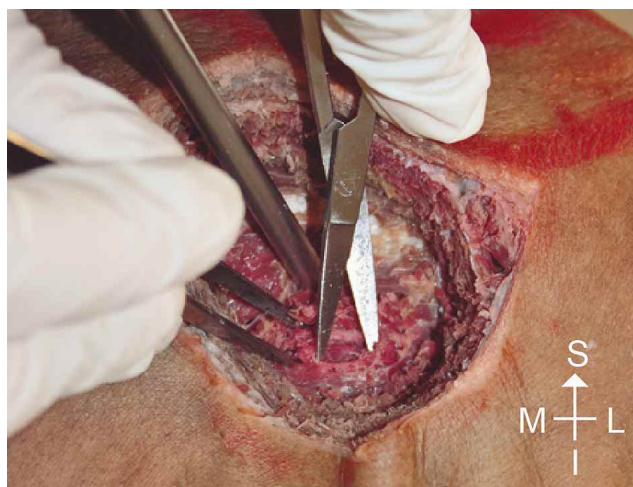
Fig. 2. Punch dissection technique used to evaluate the small microvasculature near the SPP (standard posterior portals).

After placing the SPP and arthroscopically identifying the rotator triangle references, the SAP was placed. Following portal placement, the dissections were performed using the "punch technique" (this is an original dissection technique devised by the authors). This technique involves dissecting each anatomical plane (dissecting between adipose tissue, muscle fascia and muscle fibers) within a radius of 2.5 cm, with the trocar (Linvatec T4930, 4 mm in diameter) considered as the center (Fig. 2). This technique allows for the better establishment of the *in situ* relationship between the trocar and the neurovascular structures at risk of being injured. Topographically, all anatomical planes were dissected down to the joint capsule.
