THE EFFECT OF NATURAL WEATHERING ON UNTREATED WOOD SURFACE

ABSTRACT

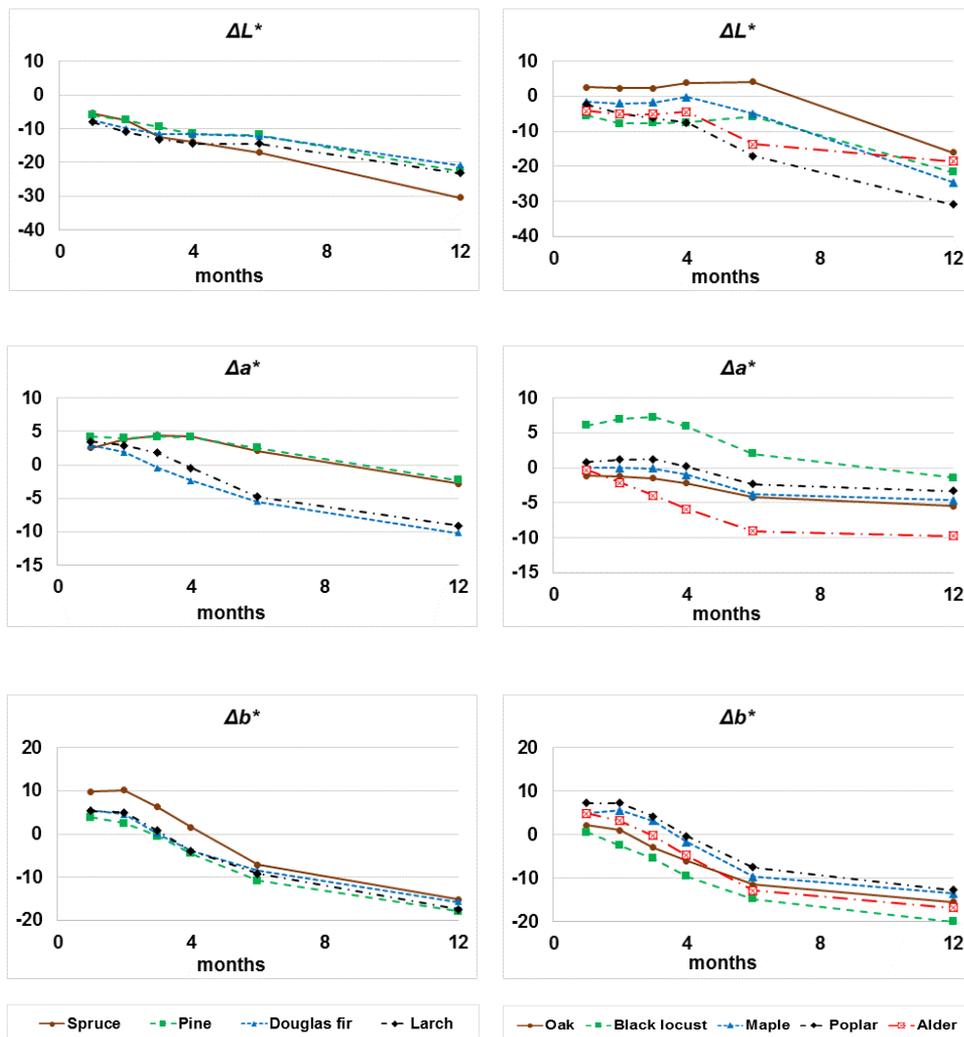
Figure 2. Colour changes of softwoods (left) and hardwoods (right) samples during 12 months of natural weathering.

The total colour difference (ΔE^*) showed a systematic trend to increase values with longer duration of exposure (Table 3). The highest mean value of ΔE^* was determined for spruce, closely followed by poplar wood. The lowest ΔE^* was observed for oak wood. The visual appearance of the samples is given in Figure 6. The trend of gloss mean values did not show any systematic trend during exposure. Generally, the gently increase was observed for the most cases after 6 months and then large decrease after 12 months of natural weathering test (Table 3). The highest change of gloss was observed for pine, the lowest one for oak wood. The lightness (L^*) values decreased after 12 months of natural weathering for all the wood species (Figure 2). The highest mean value of ΔL^* after 12 months of weathering was determined both for poplar ($\Delta L^* = -30,9$) followed by spruce ($\Delta L^* = -30,4$), the lowest one for oak ($\Delta L^* = -16,1$). The redness (a^*) values decreased after 12 months of weathering (Figure 2). The highest mean value of Δa^* after 12 months of weathering was determined for Douglas fir ($\Delta a^* = -10,2$), the lowest one for black locust ($\Delta a^* = -1,4$). The yellowness (b^*) values also decreased after 12 months of weathering (Figure 2). The highest mean value of Δb^* was observed for black locust ($\Delta b^* = -20$), the lowest one for poplar ($\Delta b^* = -12,7$).

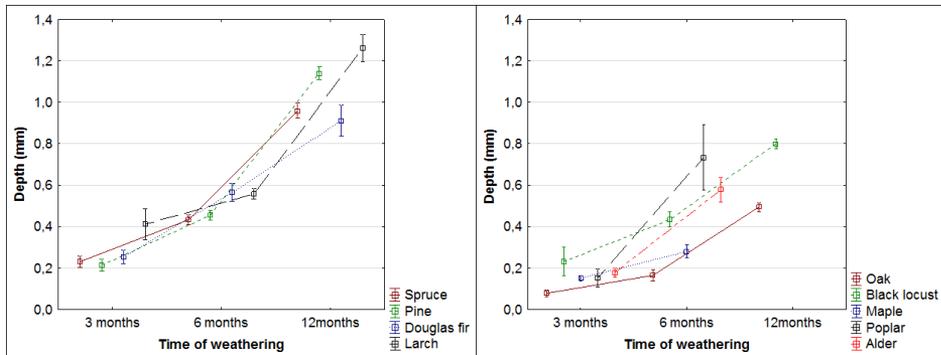
Figure 3. The depth of visible colour changes of softwoods (left) and hardwoods (right) during 12 months of weathering shown as 95% two sided confidence intervals.

The depth of colour change was relatively similar for softwood species. For hardwoods, it varied more (Figure 3). The highest value after 12 months of weathering was observed for larch (1,26 mm) and the lowest one for oak (0,50 mm). The values of the depth of the colour changes were found to be in high correlation with ΔE^* for all the wood species (Figure 4). The measurement after 6 months of exposure were done for all the samples, but after 12 months of exposure some samples cannot be measured (alder, poplar, maple) due to the presence of blue-stain fungi, which caused deeper degradation of wood and influenced the colour changes caused only by weathering. The graphs at Figure 4 show the correlation after 6 and 12 months of exposure to natural weathering. The colour changes depth values of all the wood species were in interval given by Feist (1990) and Reinprecht (2008) of 50 - 2500 μm and were found to be in high correlation with ΔE^* (Figure4). This fact confirms that during early stage of weathering the total colour change of wood surfaces is mainly caused by light decomposition of lignin which in consequence enables radical depolymerization to penetrate deeper into the wood mass. The depth of colour changes of some species (alder, poplar and maple) could not be measured after 12 months of exposure by chosen methodology due to the presence of blue-stain fungi growth in the volume of tested specimens. The penetration of UV radiation depends both on the wood

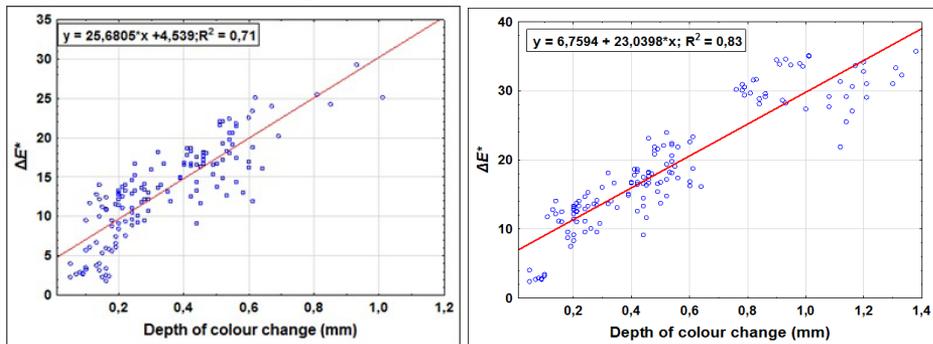
Figure 4. The correlation between total colour change and the depth of colour change during 6 months of natural weathering of nine wood species (left); and during 12 months of natural weathering of six wood species (right).

Note: The measurements were done at the same points before and after the weathering process (see Figure 1).

High correlation between ΔE^* and the depth of colour changes was determined after 6 months of weathering for all tested species ($R^2 = 0,71$) and after 12 months of weathering for all the softwoods and oak and black locust ($R^2 = 0,83$).

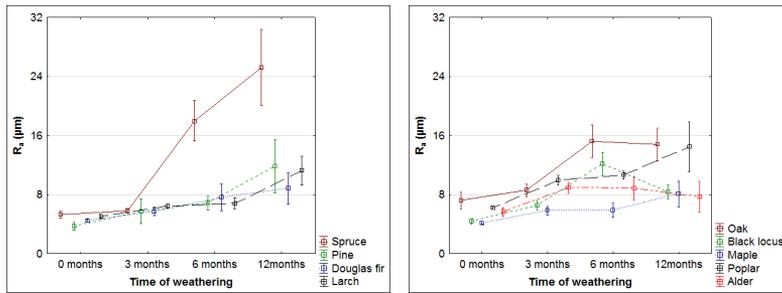
Figure 5. Changes of surface roughness of softwoods (left) and hardwoods (right) during 12 months of weathering shown as 95% two sided confidence intervals.

The roughness values (Ra^*) increased after 12 months of weathering for all the wood species as expected (Figure 5). The highest mean value of Ra^* after weathering was observed for spruce ($Ra = 25,21 \mu m$), while the lowest one for alder ($Ra = 7,70 \mu m$). The roughness measurements confirmed previous studies: value of wood roughness increases with the time of weathering (Nzokou *et al.* 2011, Tolvaj *et al.* 2014, Mohebbi and Saei 2015) because wood surfaces quickly erode (Williams *et al.* 2001). Any increased roughness can be related to natural weathering and degradation of the wood polymers (especially lignin) and removed degrading materials due to leaching after rain, mist or dew (Feist 1982). The relatively big differences in roughness values can be explained by the surface erosion occurring mainly in the early wood, due to its thin walled cells and low density (Williams *et al.* 2001). As the result, the early wood is more and faster degraded (Tolvaj *et al.* 2014) mainly for softwoods with lower density which was confirmed for spruce wood in presented study (Figure 5).

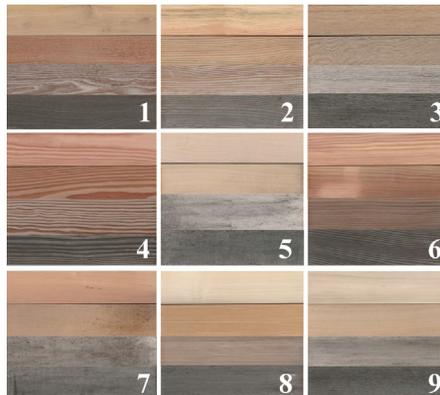
Figure 6. Colour changes of wood samples during 12 months of exposure (from up to down: reference sample, sample after 3, 6 and 12 months of exposure): 1 - locust; 2 - pine; 3 - oak; 4 - Douglas fir; 5 - maple; 6 - larch; 7 - alder; 8 - spruce; 9 - poplar
